Case study: correcting control problems on Essroc's multidrive station, horizontally curved conveyor

2013 *Transactions of the Society for Mining, Metallurgy and Exploration*, Vol. 334, pp. 472-476.

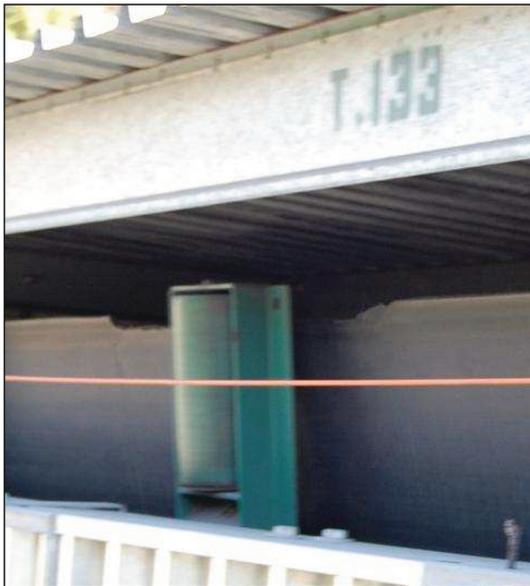
Figure 5 — Edge damage caused by excessive side travel in horizontal curves.

The control system that the drive manufacturer installed at Essroc set a constant load-sharing ratio between the head and the two booster stations, independent of the conveyor loading or of the location of the material on the belt. The problem with this control scheme has been known for quite some time and is described in Bahke (1982). While the motors' torques were shared reasonably well when the conveyor was loaded over its complete length, this control scheme created unnecessarily large tensions in empty sections of belt as the material moved through the belt (during conveyor loading and unloading). This resulted in large, and damaging, levels of side travel in horizontally curved sections (Fig. 5).

1982 paper, a fixed-ratio load sharing scheme is not suited for conveyors like CV-105. Unfortunately, this is the scheme the original designers of the Essroc conveyor installed. To illustrate the connection between the fixed ratio load-sharing scheme and the damage to the belt (Fig. 5), CDI simulated CV-105 using a model that was calibrated with the actual motor torques and tensions recorded in the field. This gave an accurate picture of the tensions in the belt for various load scenarios, and showed how these tensions would change if the control system were improved.

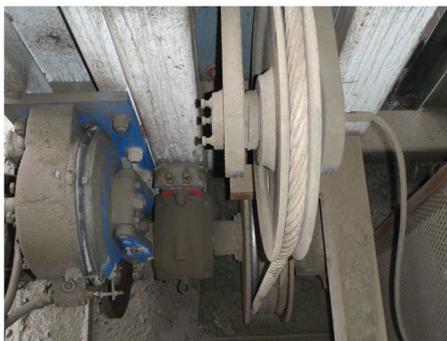
Figure 10 — Capstan take-up brake.

return side of the conveyor caused the belt in this section to slow down relatively slowly. This resulted in low belt tension in the tail section that could lead to potential belt buckling in the tail turnover (Essroc reported that on one occasion the tail turnover buckled and folded in half on the tail pulley, causing a lot of downtime).

Since this condition happens when the motors trip, it is a mechanical design problem that cannot be fixed through controls and requires a mechanical solution.

Part of the solution applied by CDI was to install a capstan brake on the take-up (Fig. 10). A capstan brake is installed on the take-up reeving and, when applied, increases the take-up resistance to motion, therefore increasing the effective take-up tension. In this case, a spring-applied, electrically released brake was selected to ensure application in case of power failure. The capstan brake is kept released at all times during operation, and only engages in the case of motor trip or power failure.
